## ***Tannery Bridge (Downton) Replacement Scheme***

WCC Bridge Number C12/217

### **Progress Report: Week 9**

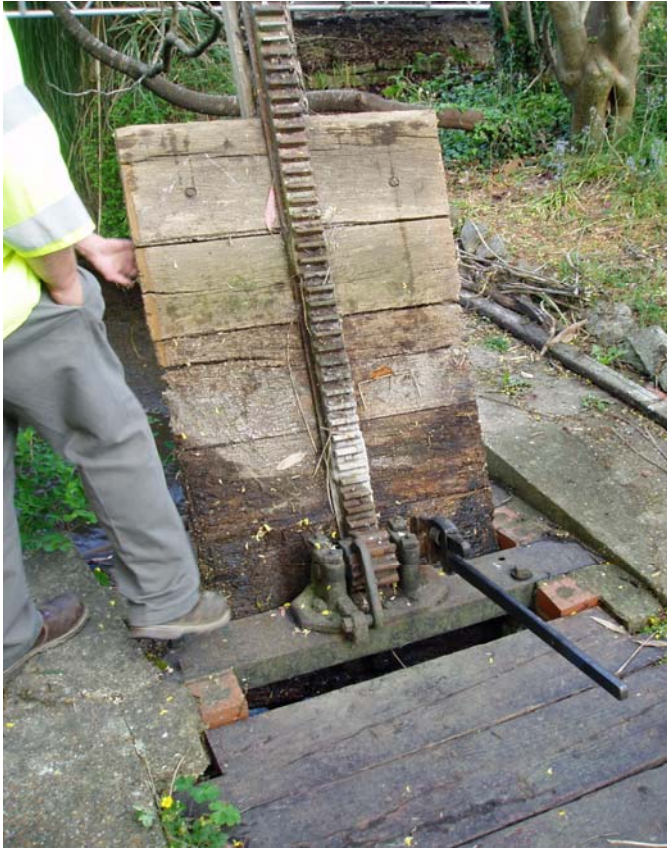
Photo 1 – Salmon Leap sluice hatch prior to refurbishment

- Works have commenced to refurbish the Salmon Leap hatch. The hatch was lifted on Monday 7<sup>th</sup> May 2007 to enable AG to source the materials (Oak/Elm) for the replacement hatch. The hatch will be removed early next week and transported to AG's workshop in Abergavenny for a replacement hatch to be fabricated. See photograph 1.

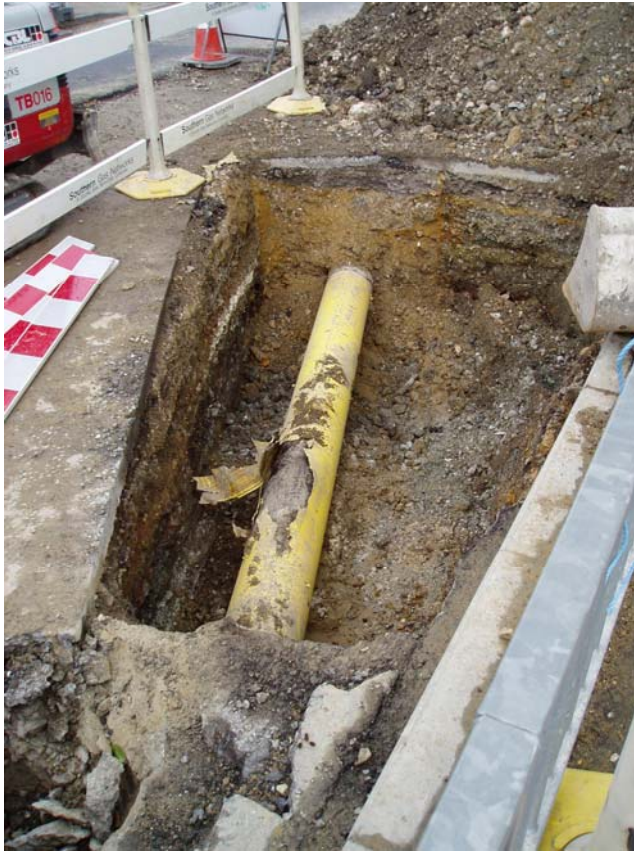
Photo 2 – Excavation of the gas networks (The Borough)

- 2) Scotia Gas Network – The excavation of services in The Borough and the installation of a new service duct beneath the temporary footbridge. See photograph 2.

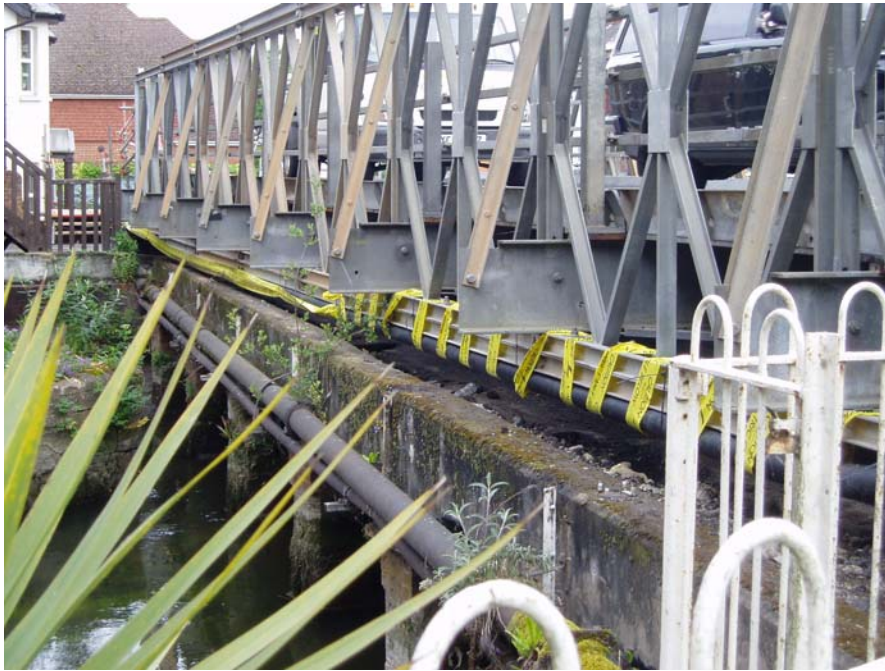
Photo 3 – Diversion of the electrical services beneath the temporary bridges

- 3) SSE Power Distribution – The excavation of services in The Borough and Waterside and the installation of a service diversion beneath the temporary vehicle bridge. The works are expected to be completed by Friday 18<sup>th</sup> May 2007 See photograph 3.

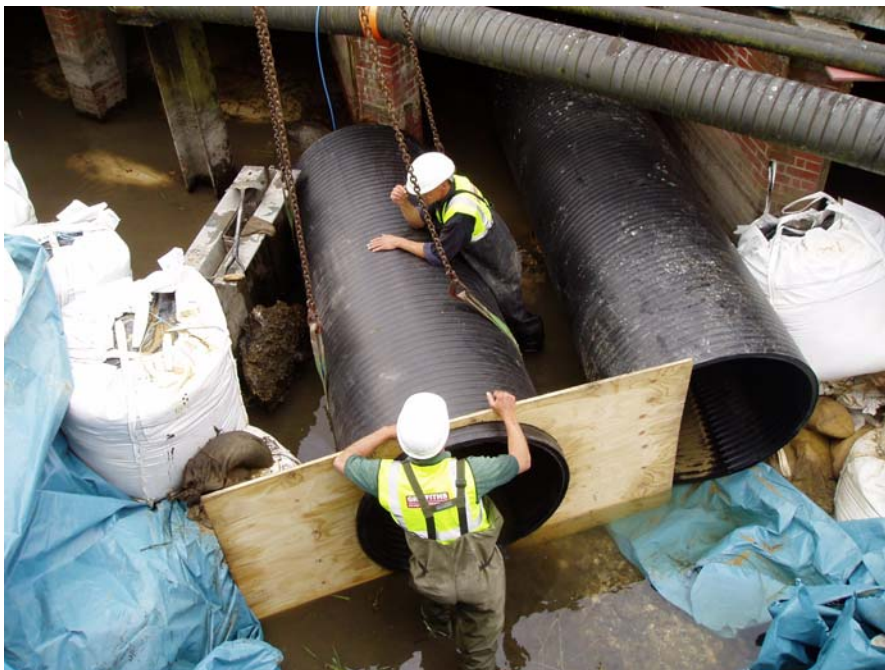
Photo 4 – Installation of the additional pipes through the dams

- Works have continued to complete the dams in front of spans 1-4 (first four spans at the High Street end). This comprised of additional sealing, using small sandbags and the installation of an additional duct through span 2 which will be opened during the damming of spans 5-9. The dams were completed early on Friday 11<sup>th</sup> May 2007. See photograph 4.

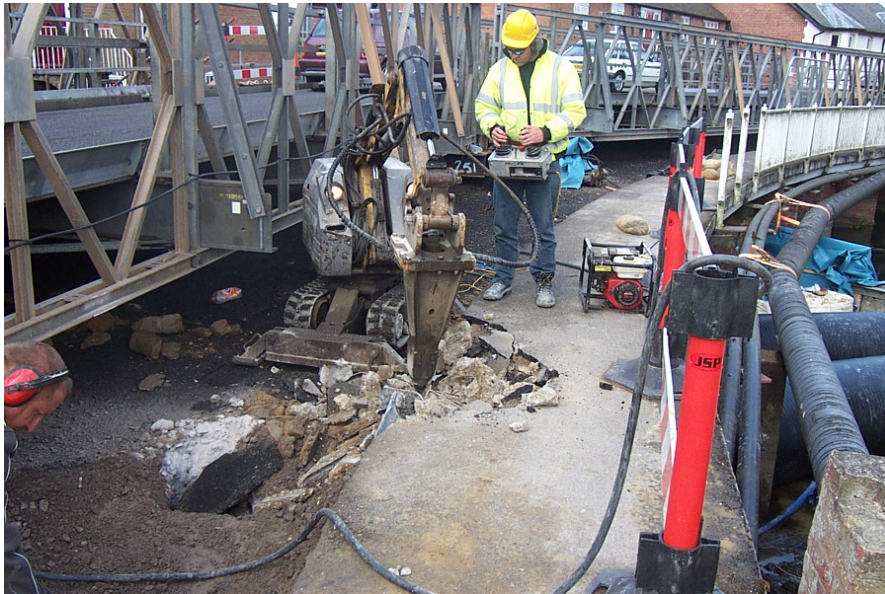
Photo 5 – Commencement of the demolition works

- Portsmouth Diamond Drilling commenced demolition of the old bridge on Friday 11<sup>th</sup> May 2007. The demolition works will continue for the next few weeks until spans 1-9 are removed. Spans 10 and 11 will be retained until they can be dammed in early August 2007. See photograph 5.
